PIRATE ATTACK!

The Lessons Learned from a Pirate Attack in the Indian Ocean

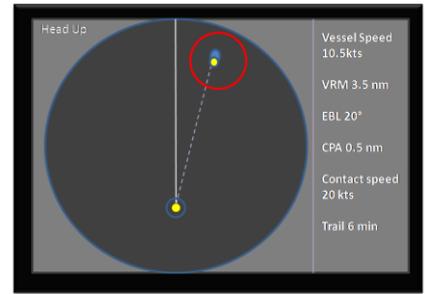
Radar Picture 3.5 - 4nm

After a few minutes and through binoculars a Single skiff could be seen and became a little clearer as it made its way towards the vessel through the white horses

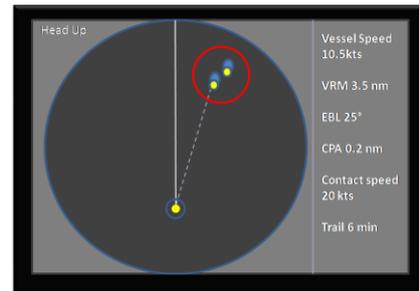
Radar Picture at 3.5nm

The bridge watch-keeper then announced that he had spotted a second skiff behind the first, on closer inspection this looked more like a whaler larger and heavier in the water.

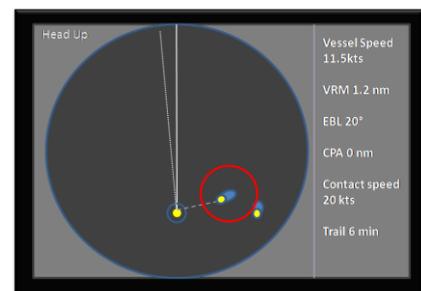
Radar Picture at 1.2nm

The attacking skiff was now closing rapidly, covering about 100 meters / yds every 10 seconds.

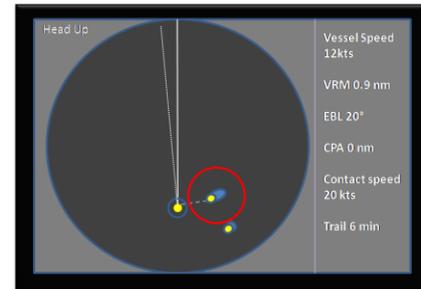
Radar Picture at 0.9nm

At approximately 700m under direction from the Team Leader the first warning shot was fired, the shot landed about 20m to the right, and 10 metres ahead of the approaching skiff, the splash from the round was clearly seen through binoculars from the bridge wing.

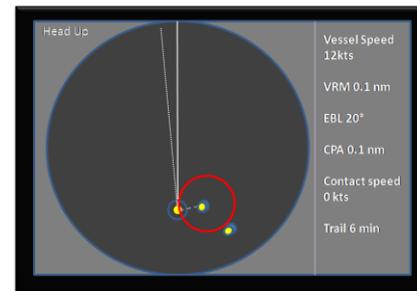
Radar Picture at 200yds

After a few seconds at least 2 probably 3 of the Pirates open fire, firing on fully automatic with their AK47's directly at the ship.

Fire from the pirates is inaccurate and probably hitting the ships hull with no effect.
